GROUNDWATER INFLUENCE TO SLOPE STABILITY ANALYSIS AT MAIN ROAD OF MALINO-MANIPI, INDONESIA

Djamaluddin¹, Muhammad Ramli¹ and Agus Salim²

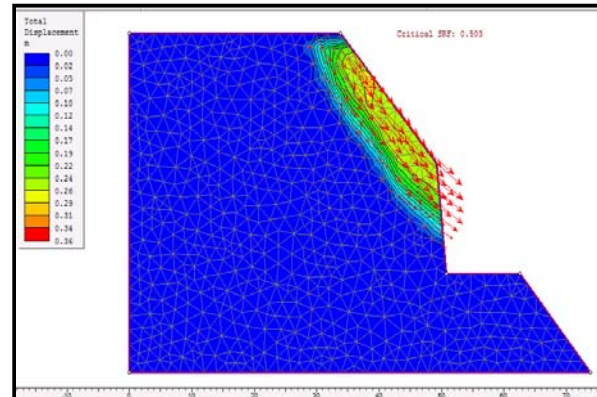
Figure-1. Total displacement distribution on the current actual slope geometry without groundwater effect.

In addition, with this simulation result the actual slope condition at present situation showed that slope will collapse eventhough without groundwater influence. Therefore, this area is quite sensitif with the slope failure occurence. Distribution of the total displacement along the surface shows unstable condition and displacement direction showed with arrow sign on Figure-1. By using simulation with 1,500 elements results total displacements in the slope of materials ranging from 0.02 meters to 0.36 meters.

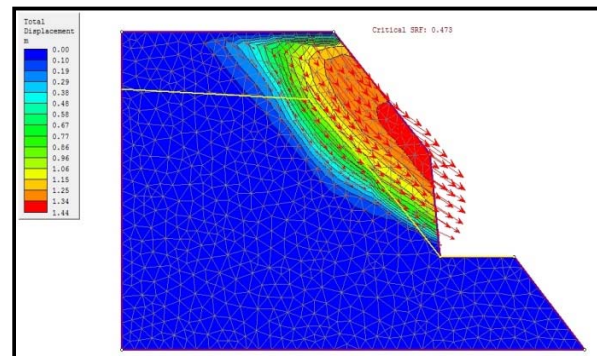
Figure-2. Total displacement distribution for the current slope with groundwater level.

The simulation by considering the groundwater level effect for this current slope geometry estimated the SF value of 0.452 and 0.473. This groundwater causes decreasing value of the SF of 0.500 to 0.452 and of 0.503 to 0.473. Total displacement for this condition from 0.10 meters to 1.44 meters showed in Figure-2.

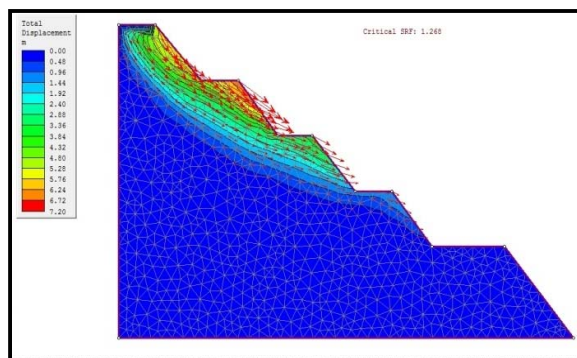
Figure-3. Total displacement distribution on cut-back slope without considering groundwater effect.

Through number of simulation schemes were decided that the proper slope design by constructing slope with slope bench of 53° and overall slope angle of 37° . The value of the safety factors for this design by avoiding of groundwater influence are 1.396 and 1.268 Distribution of maximum shear strain occurs around the top surface of the slope that can lead to landslide in the site. The analysis by using 500 elements shows that the stress distribution occurred around the top surface of the slope of 0.06 to 0.96. Distribution of maximum shear strain on the slopes by using 1, 500 elements are 0.10 to 1.44. Furthermore, the total displacement distribution about 0.48 to 7.20 meters and movement direction showed with arrows on Figure-3.

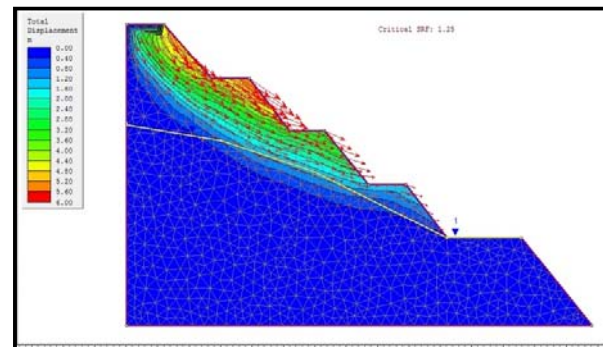
Figure-4. Total displacement distribution on cut-back slope with groundwater level simulation.

with 500 element, and various from 0.473 to 1.250 for simulation with 1,500 elements. Similar with the resulted SF without considering the groundwater level, the slope with bench inclination of 53° and overall slope inclination fo 37° is still stabel. For this slope design, the groundwater level affected the SF for the cut-back slopes by decreasing value from 1,396 to 1.343 and from 1.268 to 1.250. Based on these estimated safety factors, the proposed new design of cut-back slope is quite stable with groundwater changes. This indicates with small decrease of the SF value by considering the groundwater condition. Influence of groundwater level simulation results a total displacement 0.40 to 6.0 meters (Figure-4).

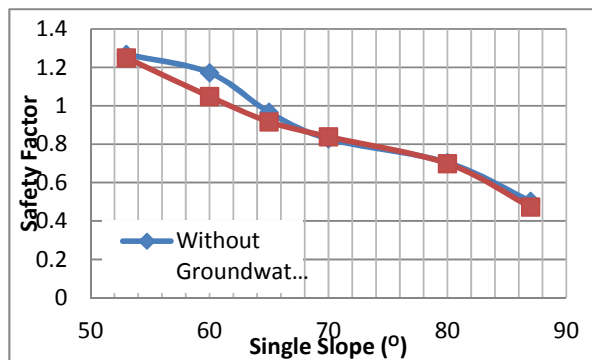
Figure-5. Comparison the simulated SF by with and without groundwater consideration.
